Energy Efficiency Opportunity Assessment of Corporate Buildings

District of Invermere

Prepared by: Enerficiency Consulting
119 Head Road
Gibsons, BC V0N 1V3
604 - 886 - 9864

September, 2009

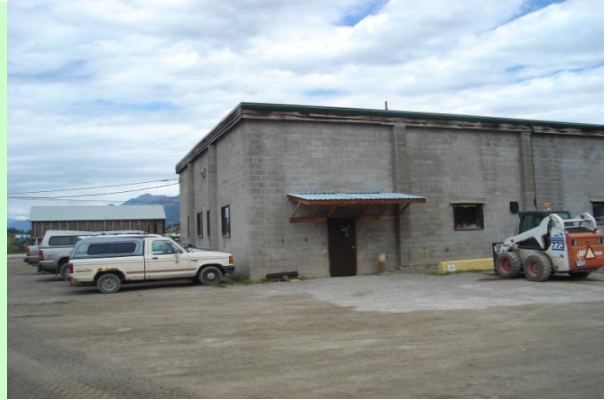
Elec	166,548 kWh	\$ 12,299	3.7 tonnes CO ₂ e
Fuel	- GJ	\$ -	- tonnes CO ₂ e
Total	600 GJ	\$ 12,299	3.7 tonnes CO ₂ e

<i>PW Yards & Buildings</i>	<i>Typical</i>
Elec	27.1 ekWh/ft	21.0 ekWh/ft
Fuel	- ekWh/ft	- ekWh/ft
Total	27.1 ekWh/ft	21.0 ekWh/ft

**Annual Energy Cost**

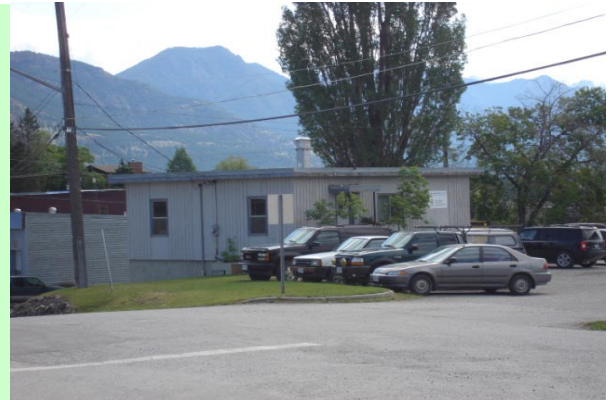
Elec	15.3 ekWh/ft	21.0 ekWh/ft
Fuel	- ekWh/ft	- ekWh/ft
Total	15.3 ekWh/ft	21.0 ekWh/ft

Annual Energy Cost

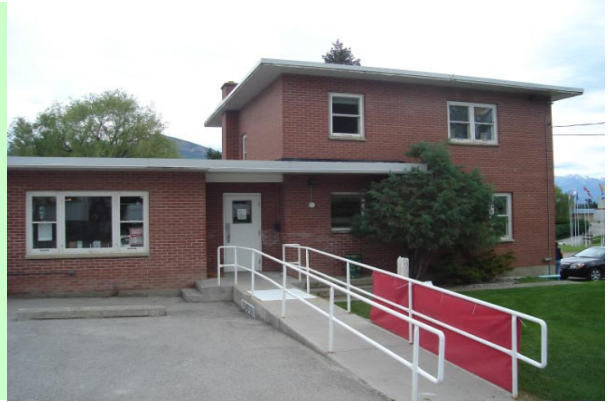
Elec	19,092 kWh	\$ 1,336	0.4 tonnes CO ₂ e
Fuel	151 GJ	\$ 3,908	11.1 tonnes CO ₂ e
Total	220 GJ	\$ 5,244	11.5 tonnes CO ₂ e

Library	Typical
Elec	5.1 ekWh/ft	12.0 ekWh/ft
Fuel	11.2 ekWh/ft	19.0 ekWh/ft
Total	16.3 ekWh/ft	31.0 ekWh/ft

Annual Energy Cost

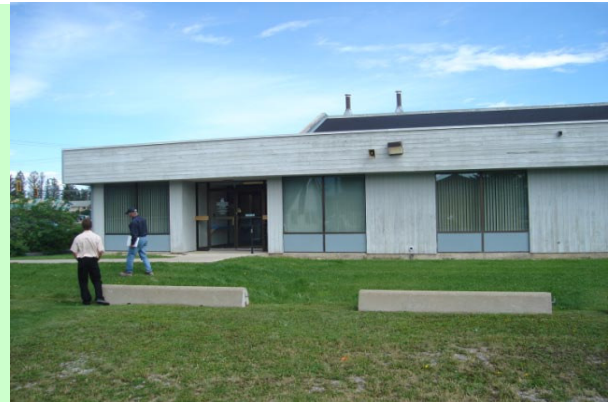
Elec	39,199 kWh	\$ 3,128	0.9 tonnes CO ₂ e
Fuel	302 GJ	\$ 6,657	18.2 tonnes CO ₂ e
Total	443 GJ	\$ 9,785	19.1 tonnes CO ₂ e

<i>Courthouse</i>	<i>Typical</i>
Elec	8.7 ekWh/ft	11.0 ekWh/ft
Fuel	18.5 ekWh/ft	22.0 ekWh/ft
Total	27.2 ekWh/ft	33.0 ekWh/ft

Annual Energy Cost

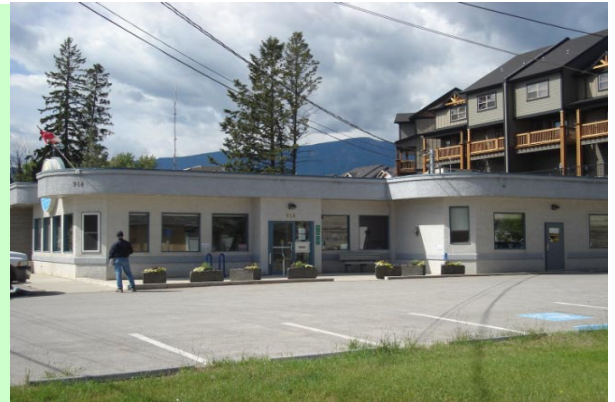
Elec	42,428 kWh	\$ 3,386	0.9 tonnes CO ₂ e
Fuel	109 GJ	\$ 2,397	6.5 tonnes CO ₂ e
Total	261 GJ	\$ 5,784	7.5 tonnes CO ₂ e

District Office	Typical
Elec	13.9 ekWh/ft	14.0 ekWh/ft
Fuel	9.8 ekWh/ft	15.0 ekWh/ft
Total	23.7 ekWh/ft	29.0 ekWh/ft

Annual Energy Cost

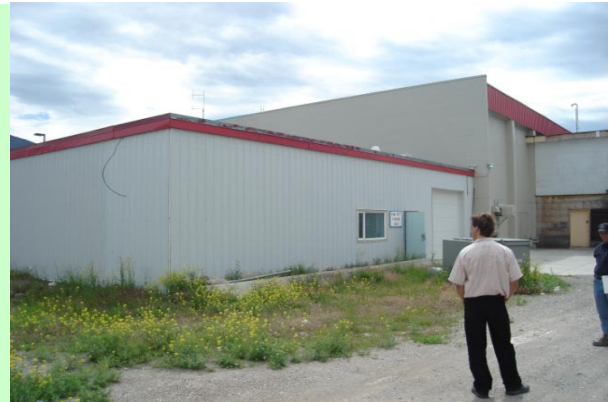
Elec	116,537 kWh	\$ 9,226	2.6 tonnes CO ₂ e
Fuel	373 GJ	\$ 8,234	22.5 tonnes CO ₂ e
Total	792 GJ	\$ 17,459	25.1 tonnes CO ₂ e

Firehall/Emerg	Typical
Elec	9.3 ekWh/ft	12.0 ekWh/ft
Fuel	8.3 ekWh/ft	17.0 ekWh/ft
Total	17.6 ekWh/ft	29.0 ekWh/ft

**Annual Energy Cost**

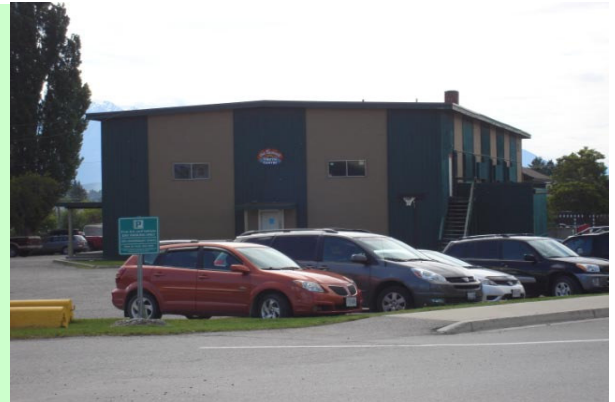
Elec	27,393 kWh	\$ 2,211	0.6 tonnes CO ₂ e
Fuel	949 GJ	\$ 21,109	57.2 tonnes CO ₂ e
Total	1,047 GJ	\$ 23,320	57.8 tonnes CO ₂ e

Community Hall	Typical
Elec	2.7 ekWh/ft	11.0 ekWh/ft
Fuel	26.4 ekWh/ft	22.0 ekWh/ft
Total	29.1 ekWh/ft	33.0 ekWh/ft

**Annual Energy Cost**

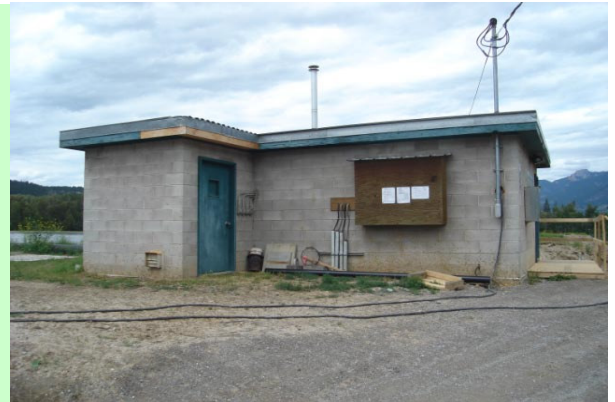
Elec	330,626 kWh	\$ 19,902	7.3 tonnes CO ₂ e
Fuel	17 GJ	\$ 383	1.0 tonnes CO ₂ e
Total	1,207 GJ	\$ 20,285	8.3 tonnes CO ₂ e

<i>Sewage Plant</i>	<i>Typical</i>
Elec	#DIV/0! ekWh/ft	- ekWh/ft
Fuel	#DIV/0! ekWh/ft	- ekWh/ft
Total	#DIV/0! ekWh/ft	- ekWh/ft

Annual Energy Cost
